**DEPARTMENT OF TRANSPORTATION****DIVISION OF ENGINEERING SERVICES**

Office of Structural Materials

Quality Assurance and Source Inspection

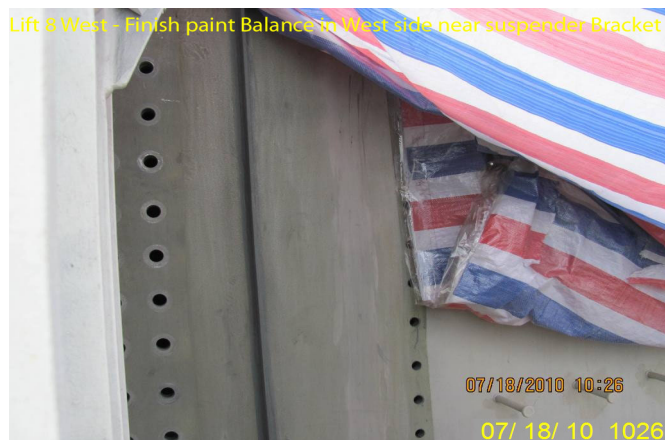
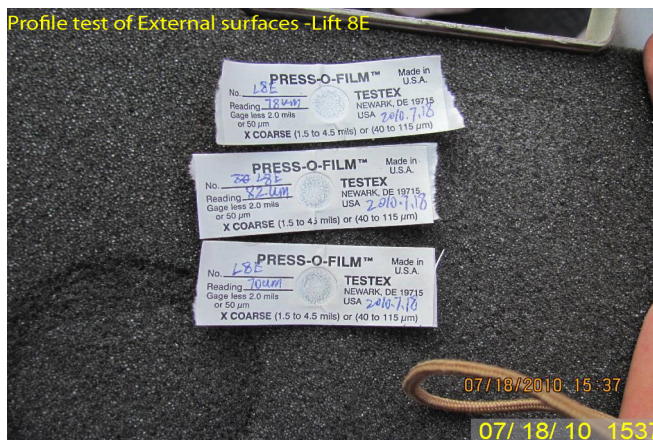
2. An inspection was requested on the OBG Pre weld seam external damaged areas reblasting, (8AE) and Pre weld seam external and internal damaged areas re blasting (8CE), vide request no. 3729 at Heavy Dock Jetty, Port no. 5. This QA inspector observed, ABF inspectors Mr. Sun, Mr. Wei and Mr. Turtle accepted the Blasted surface for Interzinc 22 application. The profile measured by ZPMC QC inspectors found to be 70 to 82 microns which is acceptable as per contract documents. It was observed that, Due to High wind speed, ZPMC QC personnels requested abf inspectors for the use of Roller for applying Interzinc 22 which was found denied by ABF inspectors after consulting this issue with International protective coatings technical service representative Mr. Lou Qian

Chuan. . (Photo of profile measured in 3 places is attached)
